# Manhole Inspection Summary

Manhole # S17A\_\_010MH

Insp Date: **4/16/09 10:33 AM**

**Location** Address: **REAR 2430 LANVALE ST**

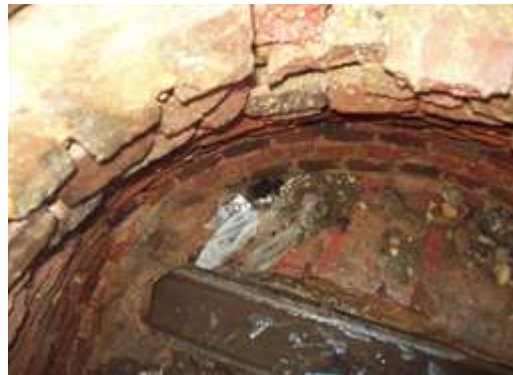
Defect 3

Condition: ☐ Sound ☐ Cracked ☐ Root Intrusion ☐ Deteriorated ☐ Leaks ☒ **Debris**

DEBRIS ON BENCH

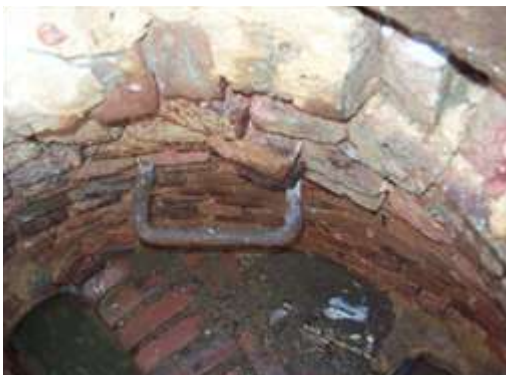
Defect 2

Count: **1** Missing: **0** ☒ **Corroded**

CORRODED STEPS

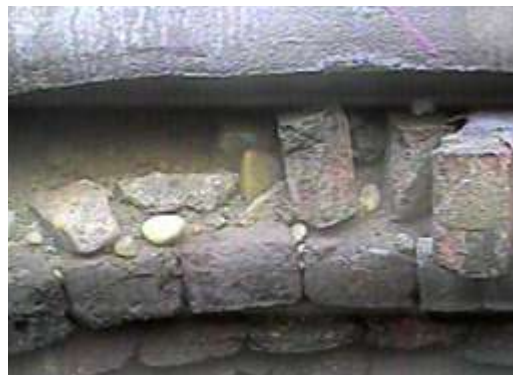
Defect 1

Condition: ☐ Sound ☐ Cracked ☐ Root Intrusion ☒ **Loose Brick** ☐ Deteriorated

LOOSE BRICKS IN CHIMNEY

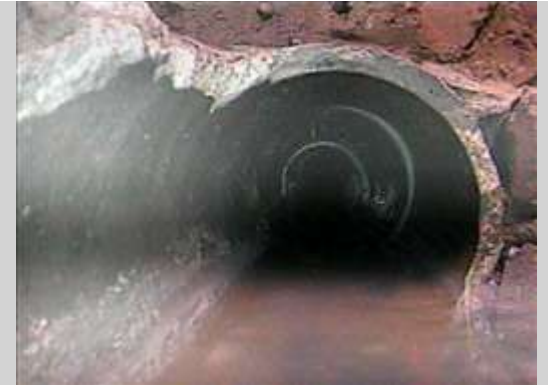
12 O'Clock Outflow

8 in. Circular Gravity Sewer  
Pipe Out @ 12 O'Clock

Infiltration: **None** Pipe Seal Cond: **Cracked**

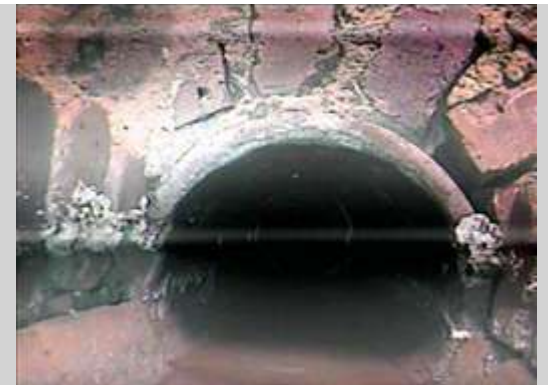
3 O'Clock Inflow

8 in. Circular Gravity Sewer  
Pipe In @ 3 O'Clock

Infiltration: **None** Pipe Seal Cond: **Cracked**
